# CONCRETE RESTORATION

## Fraser Field Stadium Restoration Lynn, Massachusetts

### Project Scope of Work

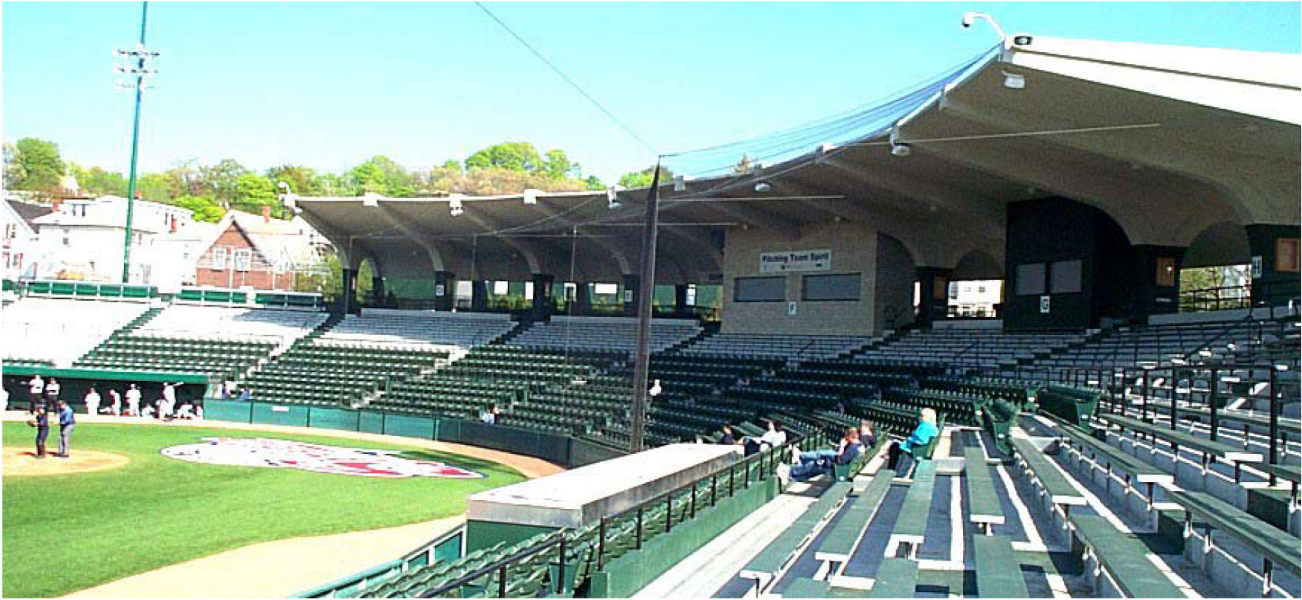
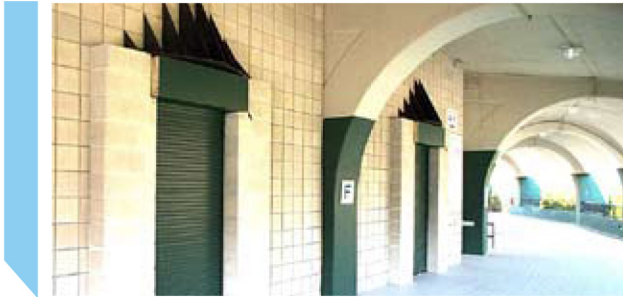
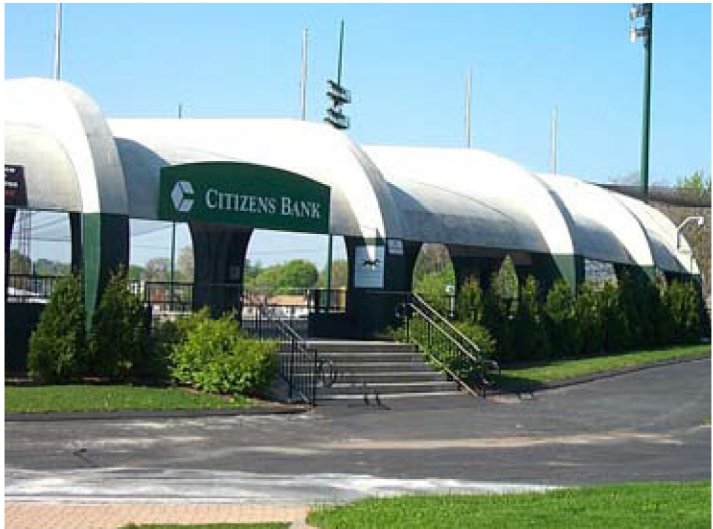
Fraser Field was constructed in the early 1940's as a 4,500 bleacher seat, cast-in-place concrete baseball stadium with a cast-in-place reinforced concrete riser system supported by cast-in-place concrete beams and columns. Of particular note is the middle portion of the grandstand, which is covered by a unique cantilevered cast in place concrete roof system in the form of an arc.

The project involved removing the deteriorated concrete on both the top and underside grandstand surfaces as well as cleaning any corroded reinforcement as required. Visible cracks were routed and scaled, expansion joints were replaced, and an elastomeric coating was applied to the top and underside roof surfaces. Finally, a pedestrian grade urethane traffic bearing coating system was applied to the entire top surface of the grandstands. The project was completed in six months.
